April 1977

# STUDY OF EROSION MECHANISMS OF ENGINEERING CERAMICS

Fifth Interim Technical Report  
(January 1, 1976 to March 31, 1977)

Solar, an International  
Harvester Group

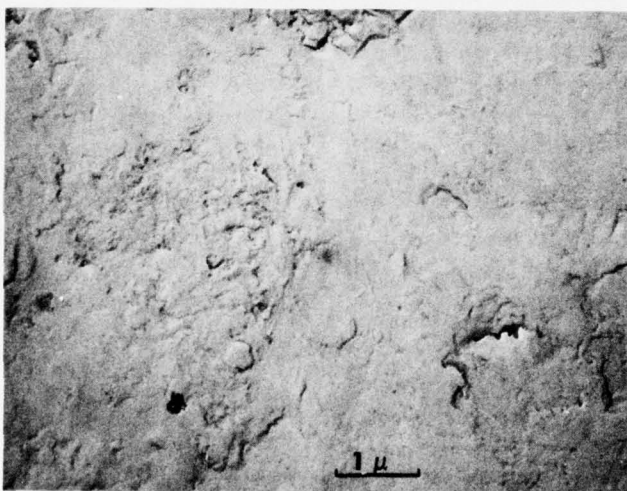
Figure 6.

Eroded Surface of Hot Pressed  
 $\text{Si}_3\text{N}_4$

$3.4 \times 10^7$  Particles  
115μ Diameter  
219 m/s Velocity  
Depth of Erosion  $\approx 4.5\mu$

Magnification: 8000X  
(TEM-Replica)

Examination of the eroded surfaces by electron microscopy has not been particularly instructive. In the case of single particle events, the impact areas are not differentiable from the as-machined ground surface, an example of which is shown in Figure 5. The heavily eroded surfaces (Fig. 6) generally have a relatively flat featureless appearance and do not provide information concerning possible mechanisms. A limited number of tests have been performed on polished surfaces and provide more information concerning particle impact response. Damage from a single 273 $\mu$  quartz particle traveling at 188 m/sec is shown in Figure 7. The chip which has been removed ( $\sim 4\mu$  dia) is quite small compared with the predicted contact area based on elastic impact of a spherical particle ( $\sim 50\mu$  dia.) and no secondary cracking is apparent. This type of damage, which is typical under these test conditions, is not characteristic of classical elastic or plastic impact response.

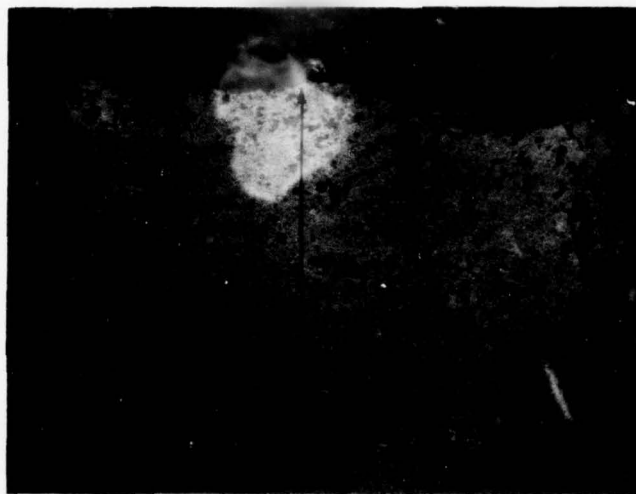
a) 385 $\mu$  Particles  
174 mps Velocity  
Erosion Depth = 375 $\mu$   
Crack = 180 $\mu$

b) 15 $\mu$  Particles  
285 mps Velocity  
Erosion Depth = 90 $\mu$   
Crack = 30 $\mu$

Figure 14. Cross Section of Heavily Eroded Reaction Bonded  $\text{Si}_3\text{N}_4$ . Arrows indicate Extent of Subsurface Cracking. Magnification: 250X

A selection of the eroded surfaces was examined in cross section to assess the extent of subsurface damage. Two examples are shown in Figure 14. The depth of the secondary cracks in Figure 14a is  $\sim 180\mu$  which is consistent with the calculated critical flaw size based on strength of this specimen. The direction of the subsurface cracks is consistent with an increased flaw size. Very little evidence of lateral cracking was observed for the conditions of Figure 14a. The subsurface damage produced with the much smaller  $15\mu$  particles is apparently different in type (Fig. 14b) than that produced with  $385\mu$  particles. No evidence of appreciable radial cracks (perpendicular to surface) was observed, and shallow lateral cracks were present. The depth of these cracks was  $\sim 30\mu$ . Lateral cracks are expected to influence strength less than radial cracks. The calculated critical flaw size for this specimen was  $\sim 90\mu$ . The explanation for this apparent discrepancy between the size of subsurface cracks and calculated flaw size is not apparent.

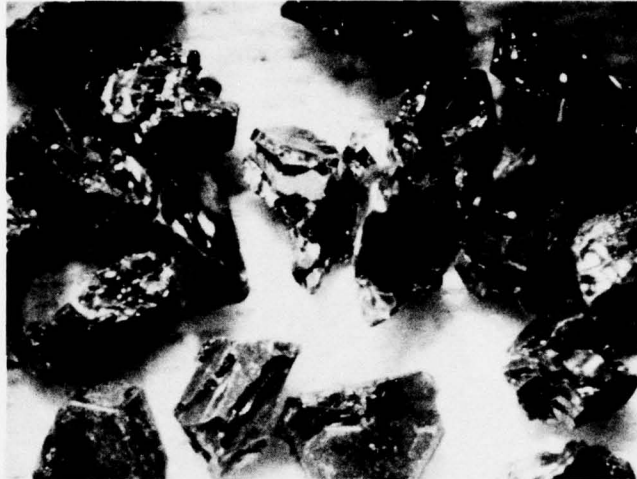
Figure 15. SiC Particles Used for Eroding MgF<sub>2</sub>  
Magnification: 14X

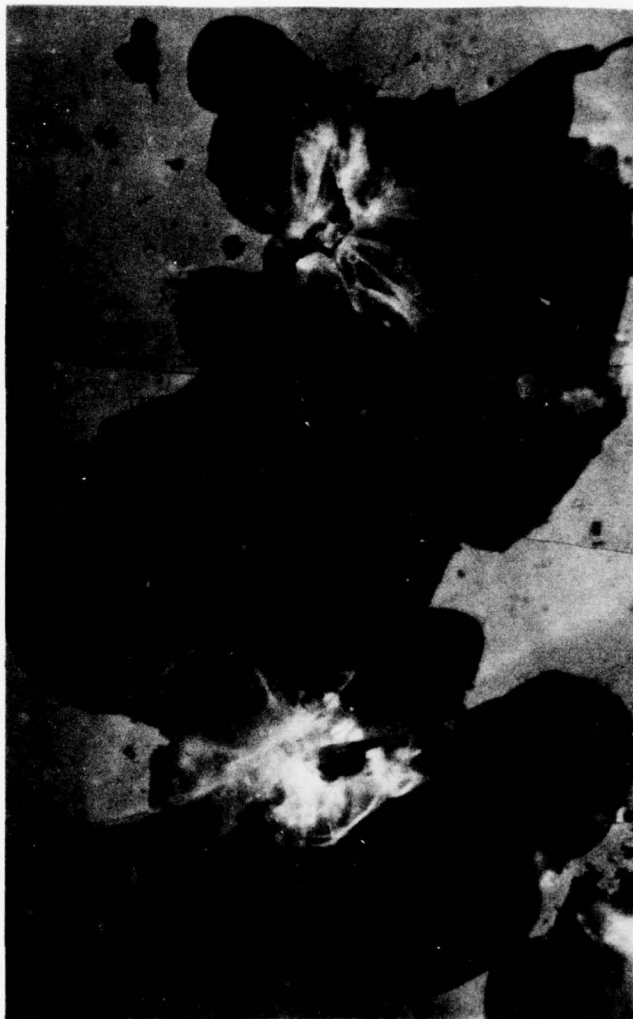
126 m/sec Velocity  
2 Impacts

30 m/sec Velocity  
3 Impacts

Typical Particle

Figure 16. Erosion of  $\text{MgF}_2$  by SiC Particles. Magnification: 40X

The purpose of this phase of the investigation was to determine the extent and type of damage produced by coarse SiC particles on a  $\text{MgF}_2$  target (Irtan I, produced by Kodak). The particles, obtained from Abrasive Division, Bendix Corporation, are those used in some aircraft carrier decking. The particles are irregularly shaped and angular as shown in Figure 15. The particle size ranges between 660 and  $1346\mu$ . Tests were performed at 6 velocities (125, 104, 81, 37, 30 and 15 mps) considered characteristic of conditions created during take-off and landing of aircraft on a deck surface impregnated with these particles. Since damage was expected to be extensive, only 6 particles per test were used. Damage was sustained by the  $\text{MgF}_2$  under all test conditions. Examples are shown in Figure 16. A typical SiC particle is included to illustrate relative size of damage produced and material removed. Plastic impact response was observed for all velocities. Plastic impact response is characterized by fracture propagating from the plastically deformed contact area. The two types of fracture are radial cracks which propagate radially outward from the contact zone, and lateral cracks that initiate under the contact zone and propagate on planes nearly parallel to the surface. Material removal occurred primarily by loss of the volume bounded by the lateral cracks. For particles traveling at higher velocities, the magnitude of damage or loss produced by a single particle impact is of the same order as the particle size. At the higher velocities small chips were also seen, which presumably, were secondary damage produced by fragments from the initial impact.
